Nelson Consulting Engineers Ltd

Re: Geotechnical Assessment for the Proposed Brook Waimarama Sanctuary Predator Fence Alignment, Brook Valley, Nelson

RM085099

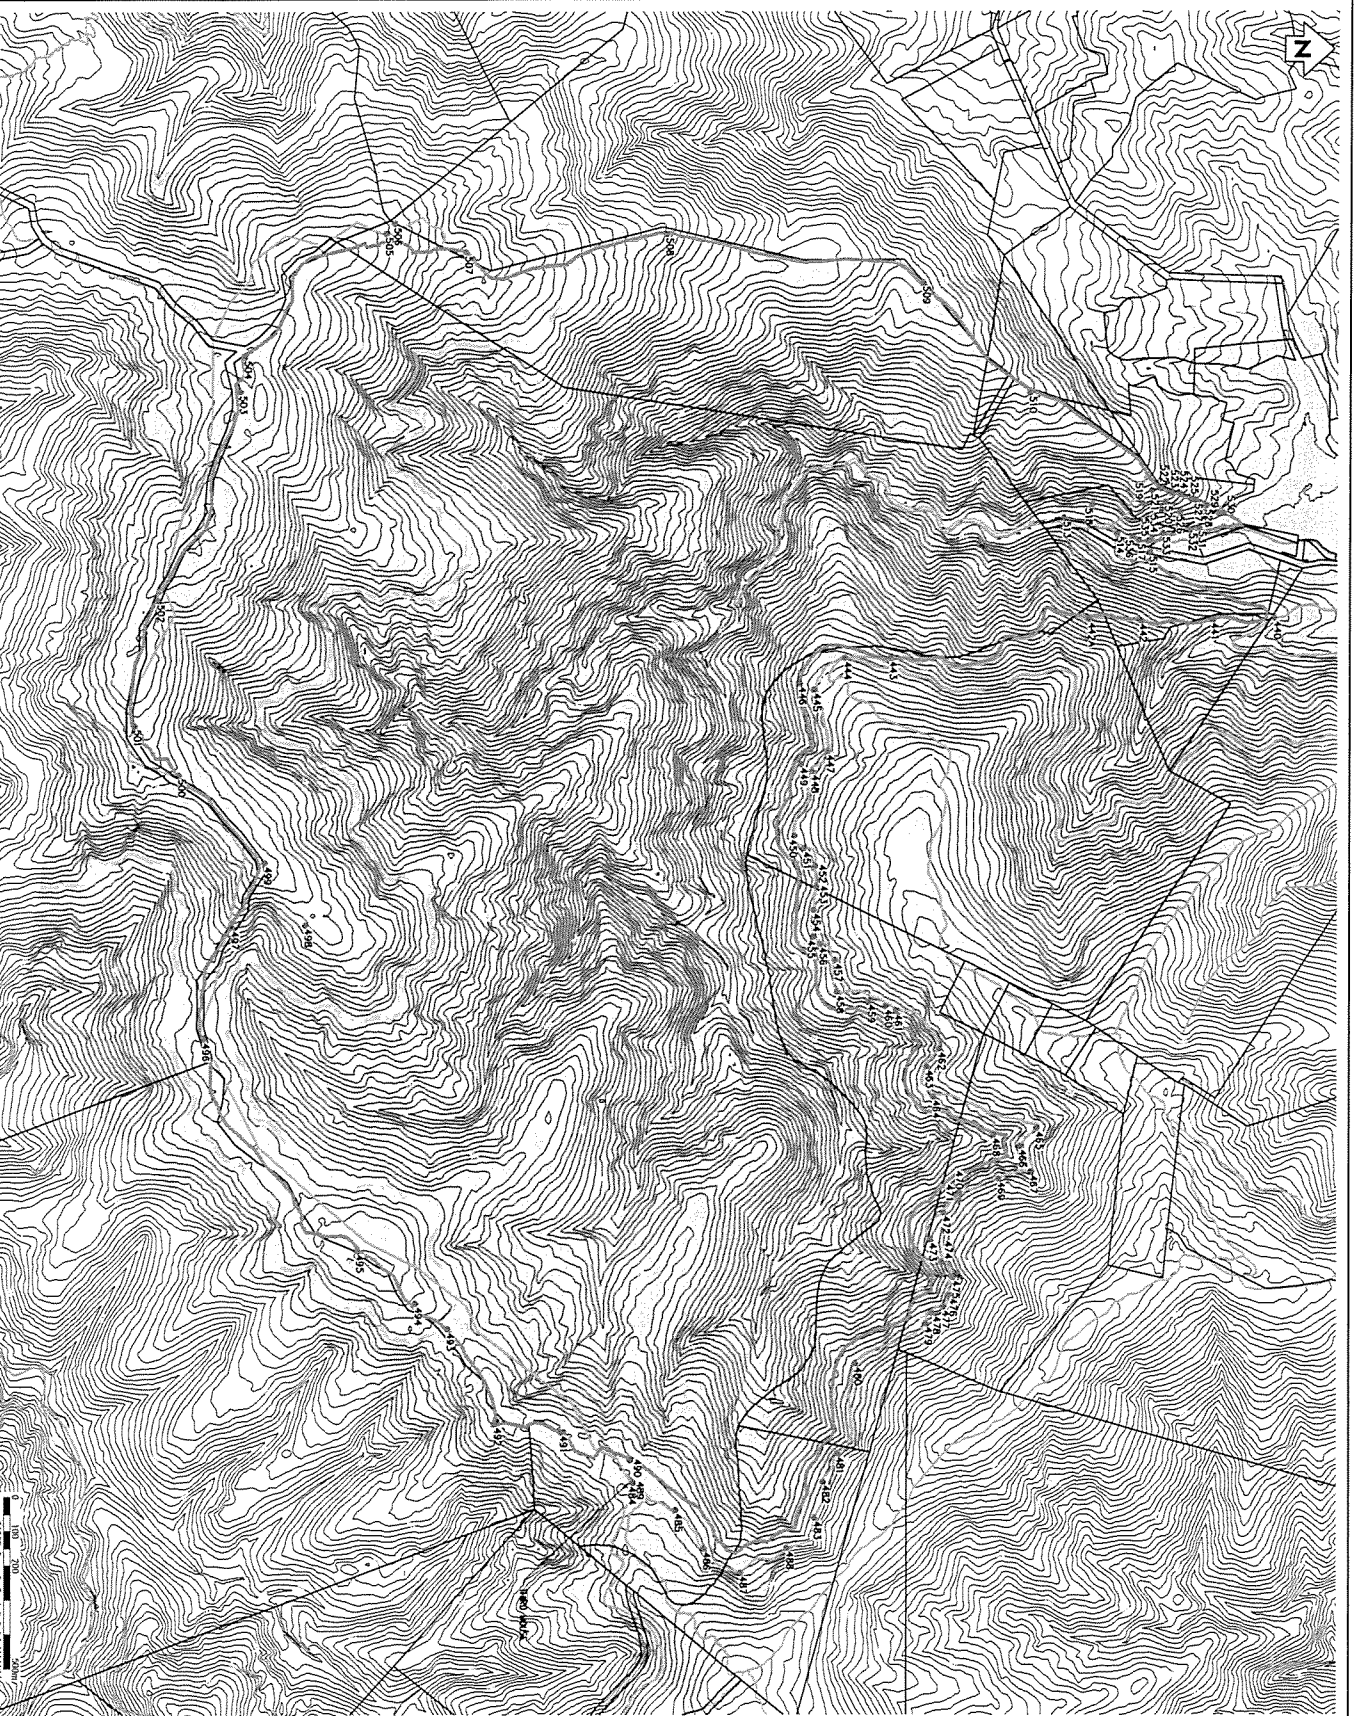
BROOK WAIMARAMA SANCTUARY TRUST
 BROOK VALLEY, NELSON
 GEOTECHNICAL ASSESSMENT FOR PREDATOR FENCE LINE ROUTE
 TOPOGRAPHIC ANALYSIS

In addition we undertook a topographic analysis using an AutoCAD Civil3D digital terrain model. The results are shown on the *Topographic Analysis* plan attached to this report. The digital model is based on 5m contour intervals derived from the NCC GIS.

This section generally traverses steep (>30°) terrain as shown on the *Topographic Analysis* plan. Significant sections of the alignment crosses moderately steep (<30°) slopes meeting the typical cross section specifications. However, the variable topography also comprises deeply incised gullies and tributaries of Brook Stream, steep spurs, and very steep rock outcrops / bluffs.

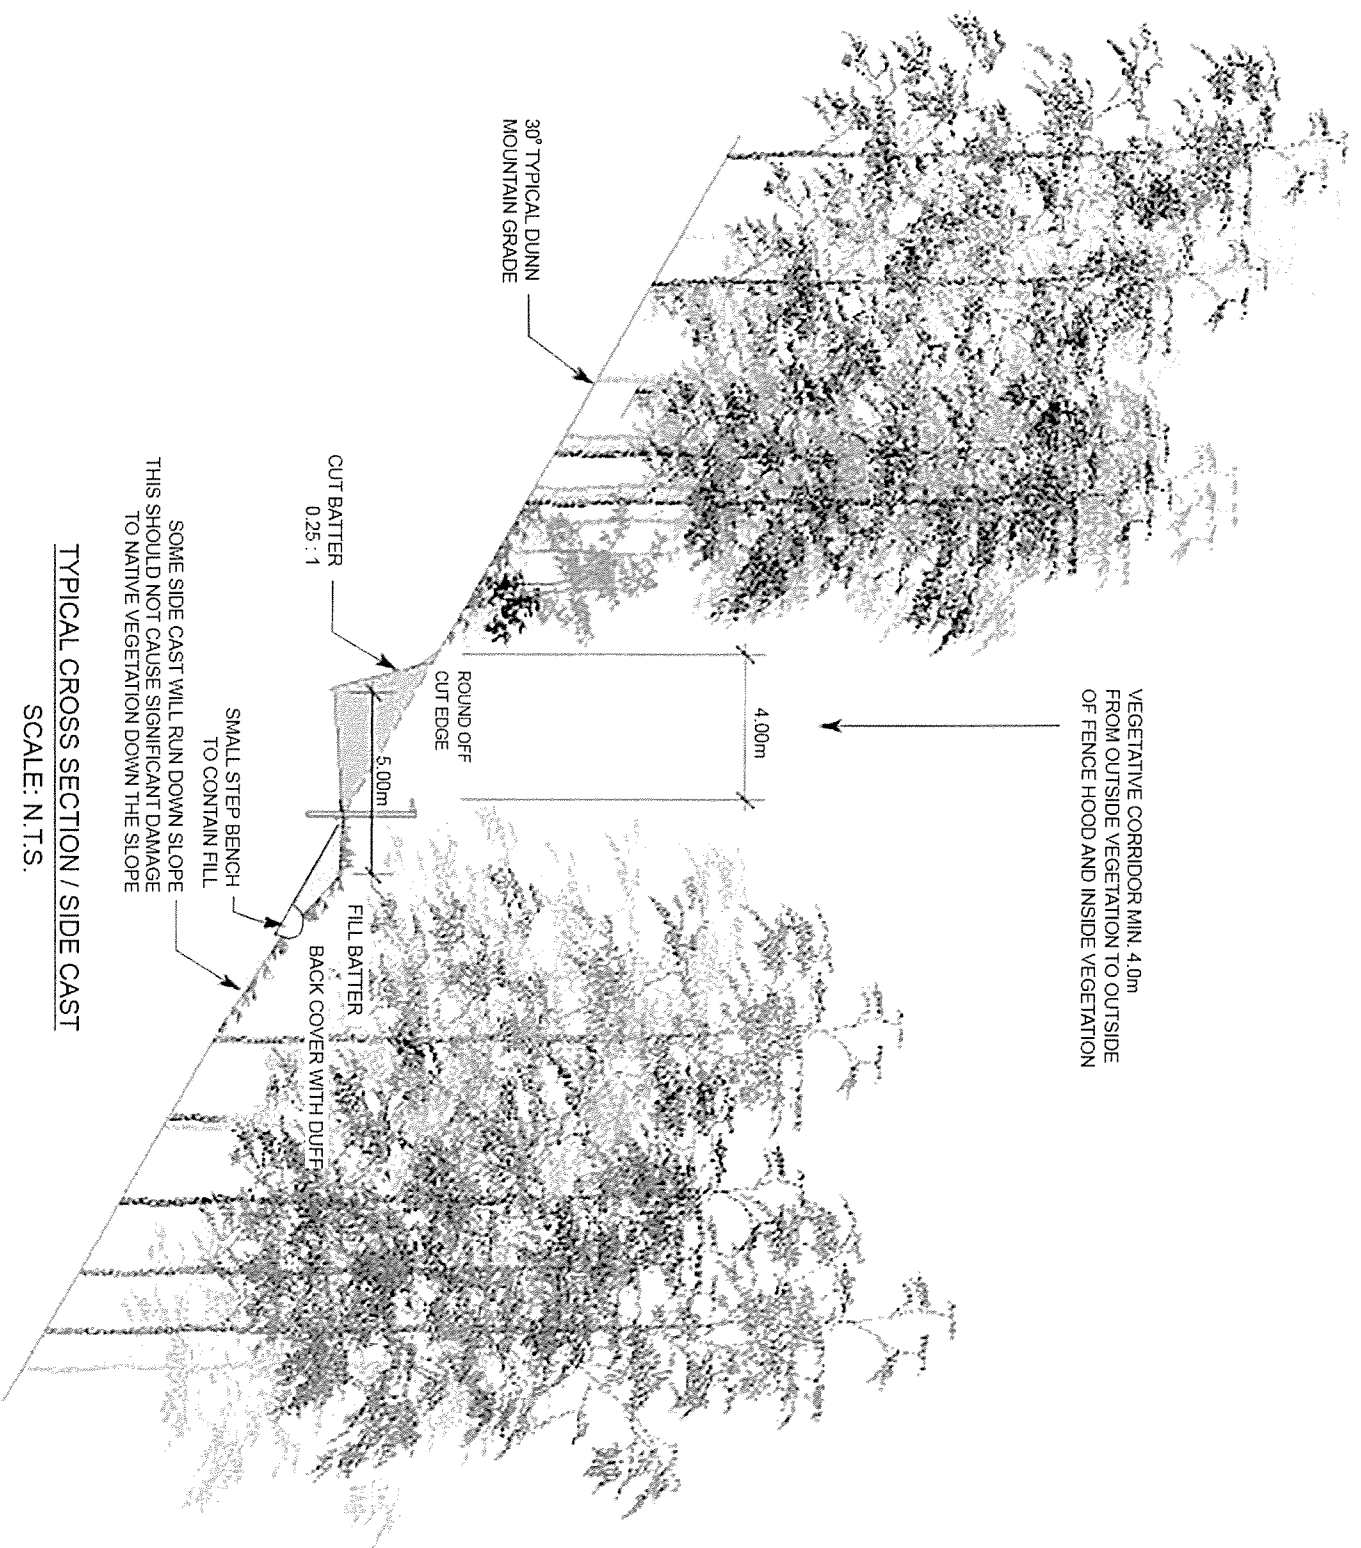
FIGURE 1

The proposed typical fence track formation prepared by Opus, is indicated on the contract drawings and Resource Consent application, a copy of which is appended to this report (Figure 1).

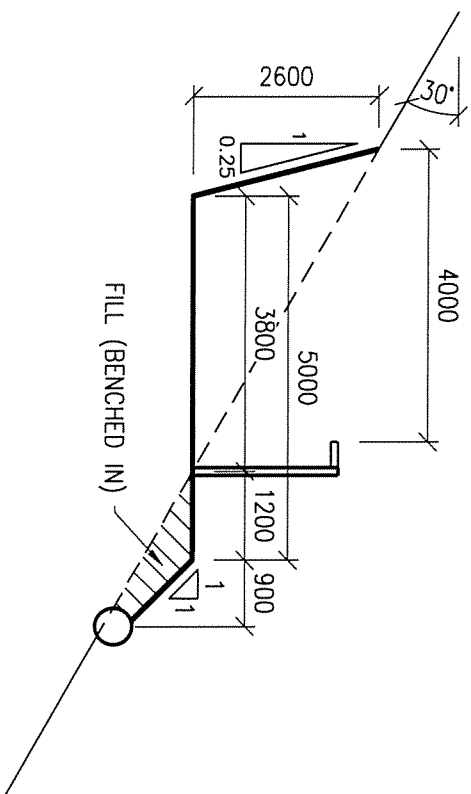
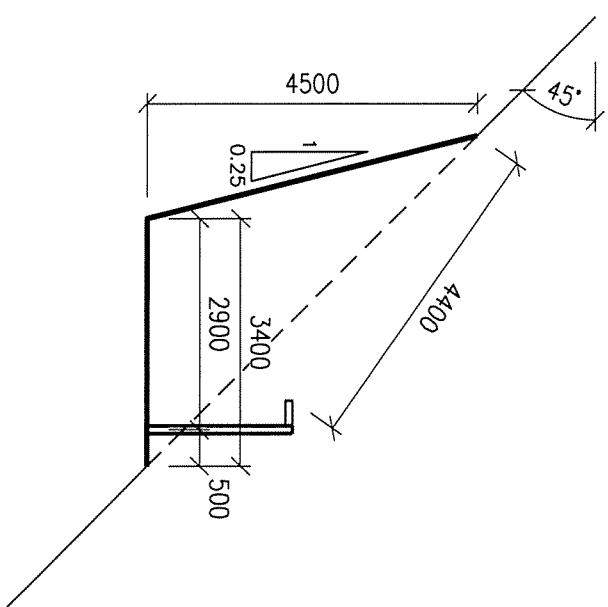
TRACK FORMATIONS

The proposed track formation design indicated in the Resource Consent documentation is based on ground slopes up to 30° and a cut batter of 0.25 (H):1(V). As indicated on the attached *Figure 2 Track Formations* drawing, at 30° a cut bench of about 3.8m width can be created with a 2.6m high cut batter. Placing additional fill to 1.2m width, can provide an overall track width of 5m. This portion of fill provides access to the downhill side of the fence and is not required to carry temporary or maintenance vehicle loads. The fence posts are to be founded in native ground and not the fill wedge, which may settle or have other localised stability issues. These are general expected to be resolvable with maintenance and as adjacent plant roots take hold. The proposed formation is generally expected to perform satisfactorily and be cost effective for flatter areas and slopes up to 30° and slightly steeper.

As previously mentioned, the proposed track alignment crosses a significant portion of land with slopes of greater than 30°. About 3600 m of new track formation is proposed to cross land with steep slopes between 30° and 45°. Another 300m crosses very steep slopes over 45°. The steepest slopes might be avoided by local shifts in alignment, but in keeping to the proposed sanctuary perimeter as much as possible, some of the steep to very steep slopes will be unavoidable.

The proposed typical track formation would not work efficiently on these steep slopes. At slopes steeper than 35° the fill batter will be difficult to construct. At 45° and steeper the fill batter would be impossible to construct, and a "full bench" formation would need to be considered. In this case a 5m formation would result in cut batters of up to 7m high, with more pronounced stability issues and generate a considerable and costly amount of spoils to be end-hauled. For this reason the Trust

should consider a narrower formation as suggested in *Figure 2*, which will greatly reduce construction and maintenance costs, enhance stability and lessen the visual impact.
